TP 185E
Issue 4/2007

AVIATION SAFETY LETTER

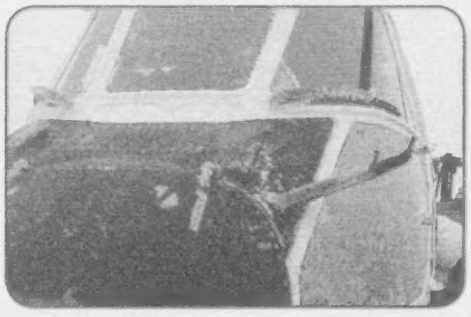
Front left of Puma with ice accretion

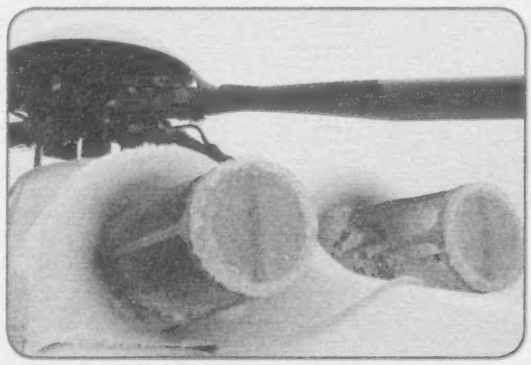
Air intakes iced-up with clean blades

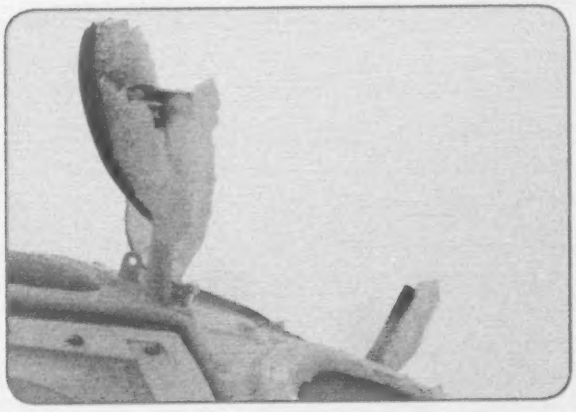
Ice build-up on the mirrors of Puma

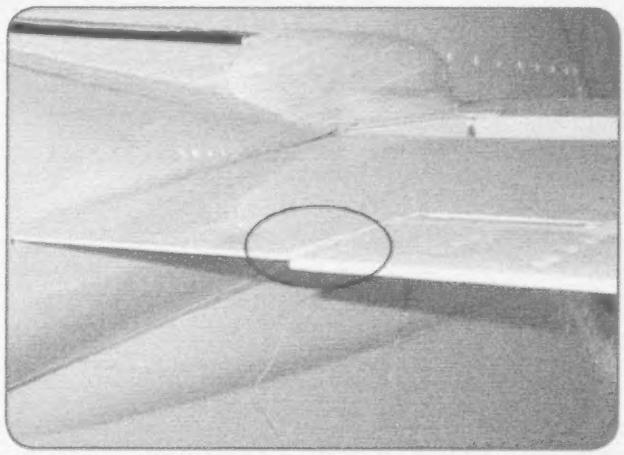
TSB Final Report A05O0112—Mis-Rigged Elevator Trim Tabs

On June 2, 2005, a Raytheon 800XP aircraft was on its first flight following painting and reassembly at an aircraft repair facility. The aircraft departed Peterborough, Ont., for Buffalo, N.Y. During the initial climb, as the aircraft speed neared 190 knots indicated airspeed (KIAS), the aircraft ran out of nose-down trim authority. The speed was kept below 190 KIAS, and the crew hand-flew, diverting to the Lester B. Pearson International Airport in Toronto, Ont., to inspect the aircraft. During the approach to Toronto, the rudder began to vibrate and seize, and the flight crew declared an emergency. The aircraft landed at approximately 13:48 Eastern Daylight Time (EDT) without further incident. An inspection revealed that the elevator trim controls were incorrectly rigged.

Circle shows the trim tab with the rigging pin in place. The trim tab should be flush with the elevator, not 1/4 in. down

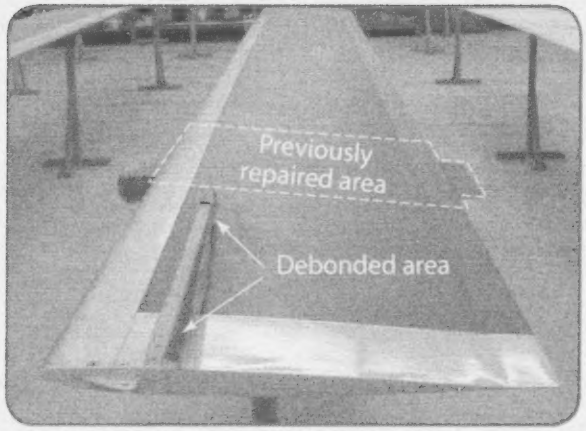
Post-flight inspection revealed that one of the main rotor blades had sustained damage. A small section of skin near the blade tip, aft of the spar doubler, on the lower surface of the rotor blade had debonded. The skin was raised and curled, but had not separated from the blade (see photo, next page). The debonded skin measured 25 in. by 2 in. between stations 263 and 288. In early 2005, the same blade had been damaged while the helicopter was parked in a hangar. The blade was then shipped to an authorized rotor blade repair shop. While paint was being stripped from the rotor blade in preparation for repair, deep corrosion pitting was discovered on the lower skin surface between stations 243 and 262, just inboard of where the debonding later occurred on the occurrence flight. Because the pitting pattern exceeded the allowable limits, the repair shop proposed a repair procedure to Bell Helicopter and received approval. The repair procedure included removing the damaged skin and replacing it with a bonded external doubler. The trailing edge trim tab was also replaced. The skin-to-inner core bonding procedure required using a bladder and heater blanket tool. This tool ensures proper curing of the adhesive by applying heat and pressure to the area being repaired. This type of repair is performed regularly to repair damaged rotor blades. The bladder and heater blanket tool that was used covered the rotor blade from its tip to a point inboard of the repair area, which included the area where the debonding took place on the June 10 flight. Following the repair using the bladder and heater blanket tool, the blade was in service for approximately four flight hours before the lower skin debonded on the occurrence flight at the spar doubler between stations 263 and 288.

Debonded lower surface of rotor blade and repair area (blade resting upside down)

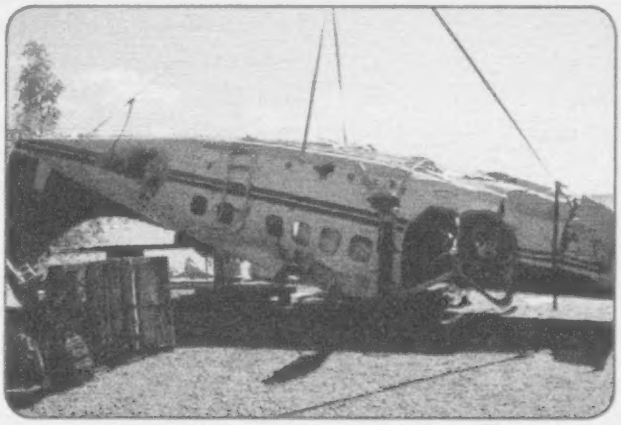
The pilot applied forward control column to counter the pitch-up tendency, but there was no response. He then trimmed the nose forward, but the aircraft continued to pitch up until it stalled at about 50 ft above the water, and the left wing dropped. The aircraft struck the water in the East Bay of Great Slave Lake in a nose-down, 45° left bank attitude. On impact, the left wing and left float detached from the aircraft, and the aircraft came to rest on its left side. The crew was able to evacuate the passengers before the aircraft submerged, and local boaters assisted in the rescue. There were no serious injuries to the crew or passengers. The aircraft suffered substantial damage.

Aircraft wreckage during recovery

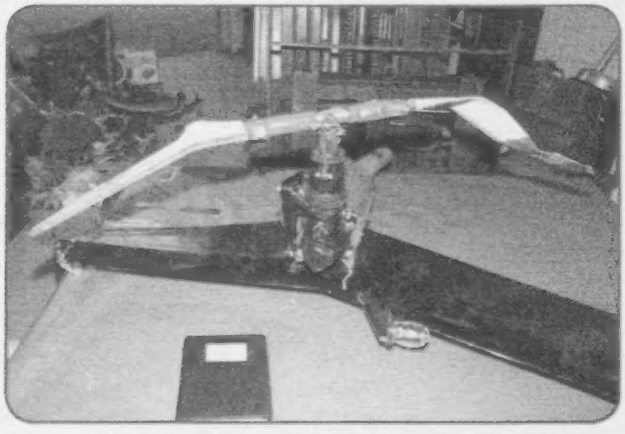
The fuel cell compartments ruptured from impact forces, and a fire ensued. The geological survey crew assisted the pilot from the burning helicopter and performed emergency first aid until the air ambulance arrived at 18:40. The pilot, the sole occupant on board the helicopter, was seriously injured. There were no injuries to persons on the ground. The helicopter was destroyed by impact forces and the intense post-crash fire.

Tail rotor during post-accident examination

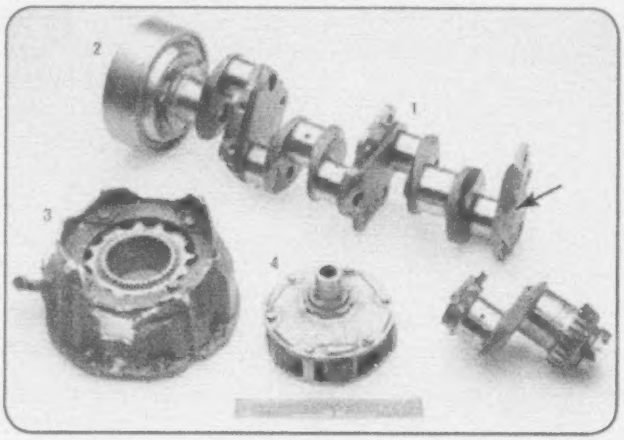
TSB Final Report A05O0258—Loss of Control—Collision with Terrain

Shown here are parts comprising the crankshaft (item 1) and parts of the engine to propeller reduction gearbox (items 2, 3, and 4). The failure location at the forward fillet radius to the number six connecting rod journal bearing is shown by the small arrow.
